EM01-004

## 2002 Q45; OIL LEVEL GAUGE DIFFICULT TO READ / SMOKE FROM TAILPIPE AT COLD START

**APPLIED VEHICLE:** 2002 Q45 (F50)

**APPLIED DATE:** Vehicles built before October 9, 2001

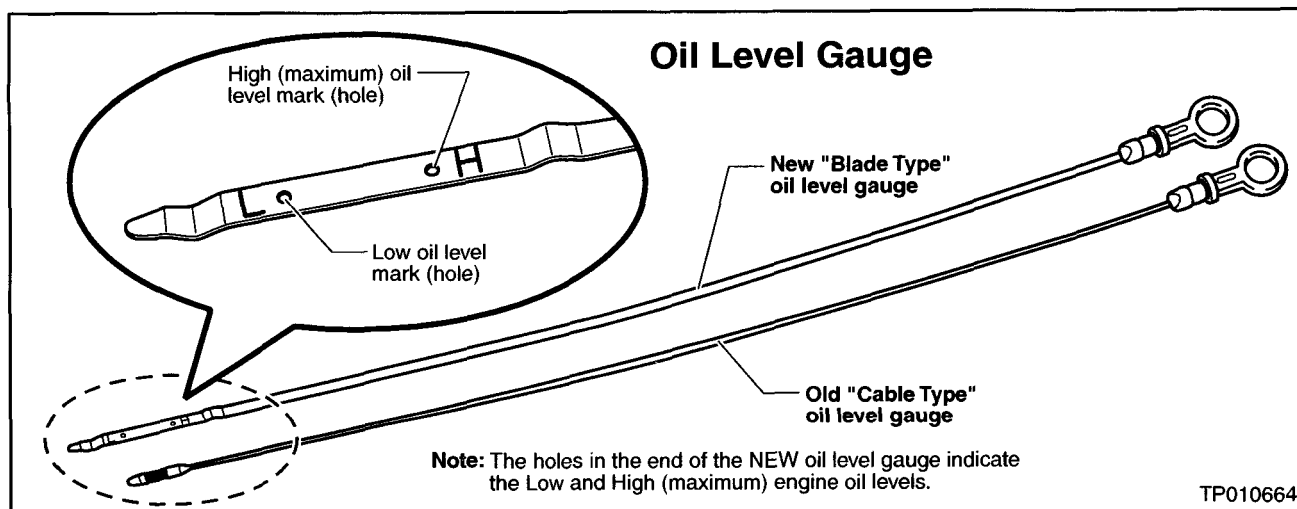
Installation of the new oil level gauge as described below, together with providing the customer with information about how to accurately read the gauge, may be helpful to the customer. The new blade type gauge is easier to read accurately than the former cable type gauge. Moreover, it is very important to follow the correct procedure when checking the oil on this vehicle, as described in steps 1 through 5 of the Service Procedure on page 2.

- The 2002 Q45 engine has an advanced cylinder head design that retains oil in the valve train area to provide proper lubrication while the engine is running
  - Time is needed, after the engine is shut down, for the oil to return to the oil pan before reading the oil level gauge
5. After 15 minutes, check and adjust (as necessary) the engine oil level to the “H” mark (i.e., the **hole** in the gauge next to the “H” mark). See Figure 1 on page 1.
